OBSERVATION OF THE NEARSHORE WATER
CIRCULATION OFF A SAND BEACH

JOHN F. BRENNAN
RICHARD P. MEAUX

MASTER OF SCIENCE

United States Naval Postgraduate School
Monterey, California

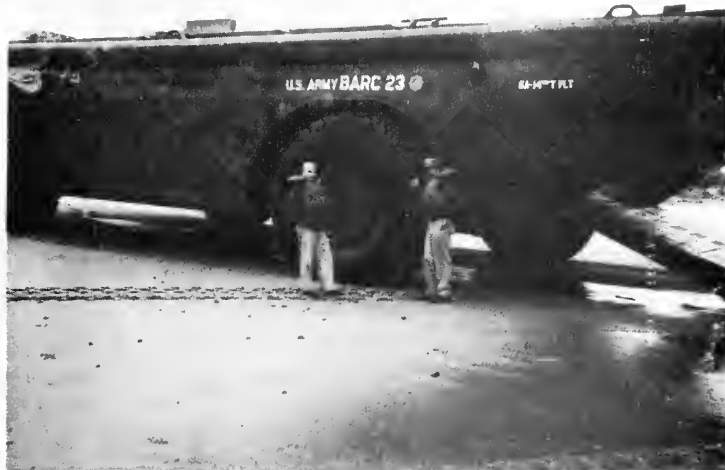
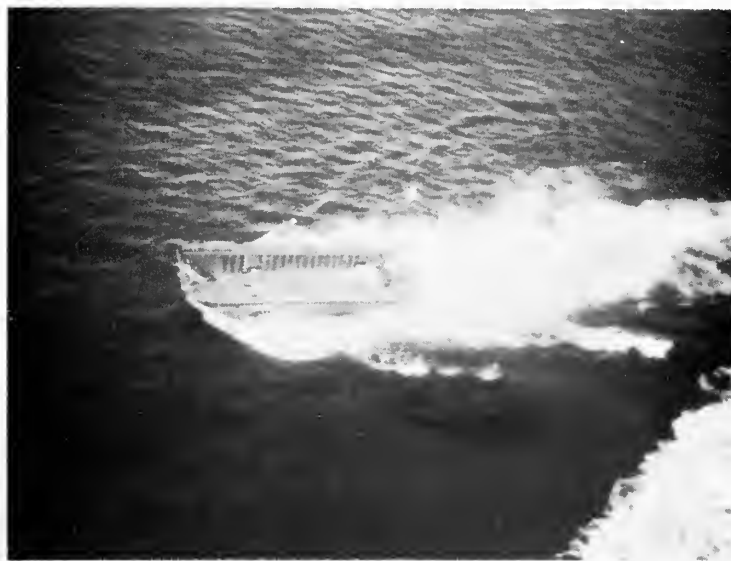
Figure 5. Army BARC.

Figure 6. BARC Underway Just Seaward of a Breaker.

In the actual surveys, an Army BARC was used to launch and retrieve the floats. The BARC, shown in Figures 5 and 6, is a large amphibious vehicle, 65-feet long and weighing 100 tons. Its ability to retrieve floats in the surf zone after it had launched them and to travel onto and along the beach made it an invaluable craft for the task.

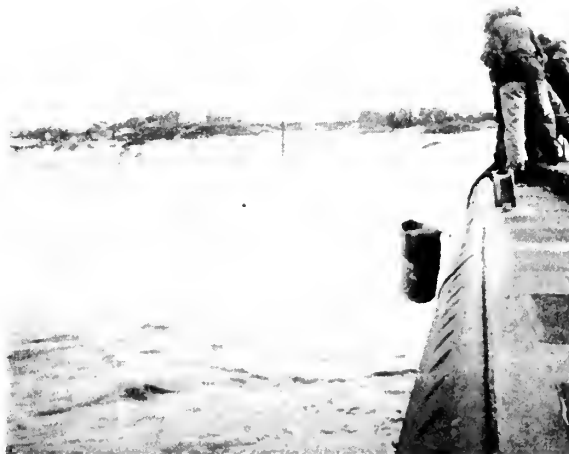
III. Weather balloons: A weather balloon filled with water was found effectively to form a unit of water which responds exactly to surface water motions while offering no sail area to the wind. Fluorescent dye was placed inside each balloon prior to filling to indicate leaks or position if the balloon was destroyed. The balloons proved very difficult to handle when full. The best system devised for filling and launching the balloons was to fill each in a 35-gallon trash can lined with kraft paper to avoid puncturing on the rough surfaces of the can, and to throw the can and balloon over the side (Fig. 23). The bottom of the can took the brunt of the impact and was retrieved by an attached line after the balloon floated free. When brightly painted the balloons were readily visible from the air. Prior to filling with water they were inflated with air and spray-painted various colors, although the results were inconclusive as to which color was best. The colors used were red, orange, yellow, metallic copper, metallic brass, metallic silver, metallic gold, and fluorescent red. Standard 300-gram weather balloons were used in these experiments and were filled with both fresh water and salt water.

Figure 23. Launching of a Weather Balloon Float .
